**Flood Control Project Maintenance
Levee Inspections**

Maintenance Issue Types Only, Levee Inspection Report By Mile - Spring 2017

Sutter Maintenance Yard Nelson Bend

Waterway	Bank	Unit Miles	Inspection Start/End	Inspector
Unit No. 01 Feather River West Levee - Nelson Bend		0.50	04/06/2017 04/06/2017	Sterling York

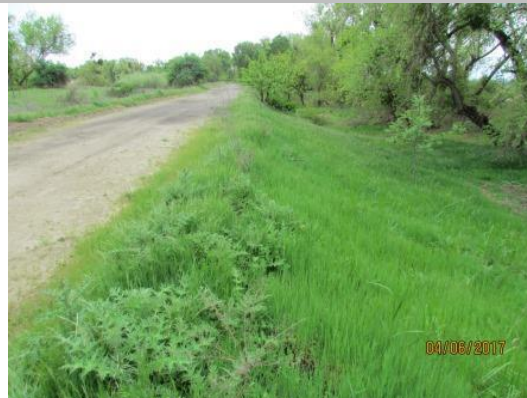
Photo 1 of 1 : SP_2017_ST0006_471_15_20170410_00008.jpg

LM Start	0.02	Rating **	U	Issue No.	15
LM End	0.42	Issue Type +	Ma	Location *	WS
Category	Earthen Levee			GPS Latitude/Longitude	
				Start	End
Item	Vegetation			38.886883 °	38.881287 °
				-121.614797 °	-121.614490 °
DWR ID	DWR_ST0006_01_f_2015_15				
Comment Code					
V2 : Remove the wild growth other than native grasses from the levee slopes.					
Inspector Comment					
Remove the vegetation and trim up the trees 5 feet for visibility.

View of the vegetation along the waterside slope looking downstream.
Spring 2017.

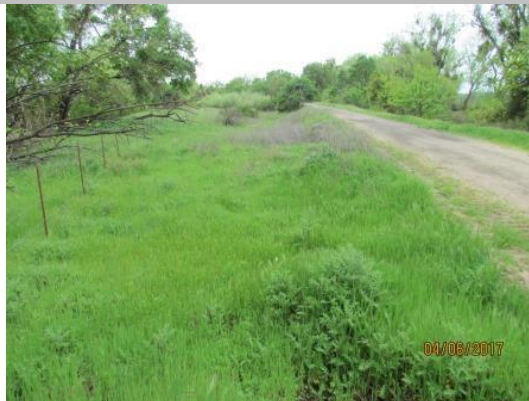
Photo 1 of 1 : SP_2017_ST0006_471_2_20170410_00007.jpg

LM Start	0.02	Rating **	U	Issue No.	2
LM End	0.46	Issue Type +	Ma	Location *	LS
Category	Earthen Levee			GPS Latitude/Longitude	
				Start	End
Item	Vegetation			38.886883 °	38.880833 °
				-121.614797 °	-121.614387 °
DWR ID	DWR_ST0006_01_f_2015_2				
Comment Code					
V2 : Remove the wild growth other than native grasses from the levee slopes.					
Inspector Comment					
Remove the vegetation, wild growth, and trim up the trees 5 feet for visibility.

View of the vegetation along the landside slope looking downstream. Spring 2017.

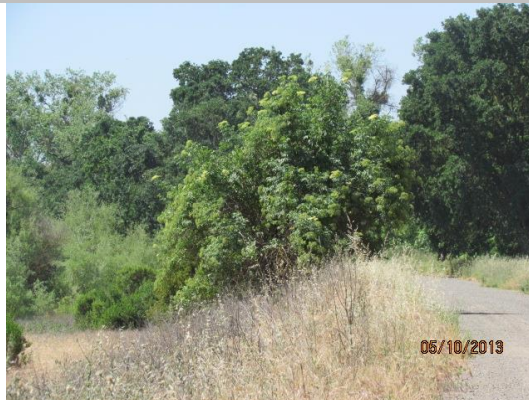
Photo 1 of 1 : SP_2017_ST0006_471_4_20170316_00002.jpg

LM Start	0.06	Rating **	M	Issue No.	4
LM End	0.06	Issue Type +	Ma	Location *	WS
Category	Earthen Levee			GPS Latitude/Longitude	
				Start	End
Item	Vegetation			38.886277 °	38.886277 °
				-121.615129 °	-121.615129 °
DWR ID	DWR_ST0006_01_s_2012_4				
Comment Code					
V4 : Elderberries are blocking visibility and flood fight capability.					
Inspector Comment					
Elderberries are partially blocking visibility.

View of the elderberries that are blocking visibility.
